Manhole Inspection Summary

Manhole # S13UU1020MH

Insp Date: **4/9/07 11:42 AM**

Location Address: **2401 BELVEDERE AVE**

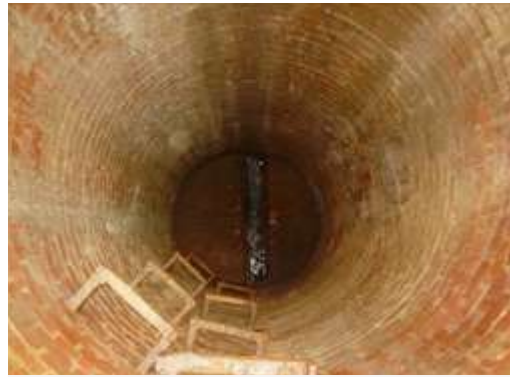
Top View

Bench ☒ Exists Material: **Brick** ☐ Parged ☒ **Debris** (not Condition related)

Steps Count: **11** Missing: **0** ☒ **Corroded**

Surcharge ☒ **Evidence Of Surcharge** Depth: **3** (ft.) ☐ Active Surcharge Present

Corroded steps. Evidence of surcharge - Bench debris.

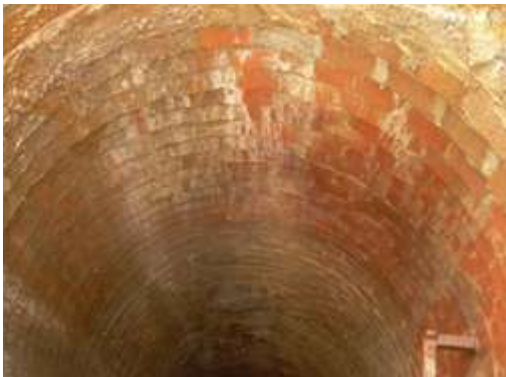
Defect

Frame Offset: **0** (in.) Condition: ☐ Sound ☐ Cracked ☒ **Leaks**

Condition: ☐ Sound ☐ Cracked ☐ Root Intrusion ☐ Loose Brick ☒ **Deteriorated**

Infiltration: ☐ None ☒ **Joint** ☐ Cracks ☐ Mortar ☐ Roots ☐ Wall

Infiltration: ☐ None ☐ Joint ☐ Cracks ☐ Mortar ☐ Roots ☒ **Wall**

Frame leaks. Adjustment deterioration and infiltration. Corbel and Barrel infiltration.

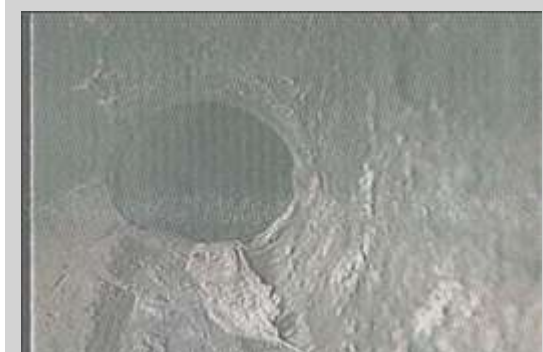
Pipe Out @ 12 O'Clock

Deposits: ☐ None ☐ Mud ☐ Sludge ☒ **Debris** ☐ Grease

Infiltration: **None** Pipe Seal Cond: **Cracked**

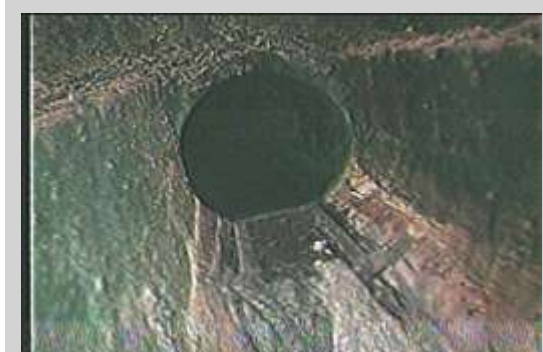
Pipe In @ 5 O'Clock

Condition: ☐ Sound ☐ Cracked ☐ Root Intrusion ☒ **Deteriorated** ☐ Leaks ☐ Debris

Channel deterioration.

Infiltration: **None** Pipe Seal Cond: **Cracked**
